Ludger Dederich, Bonn, and Jochen Simon, Freising

The Snowy Winter of 2005/06 – “Snow from Yesterday?”

Consequences for Wood Construction in Agricultural Buildings

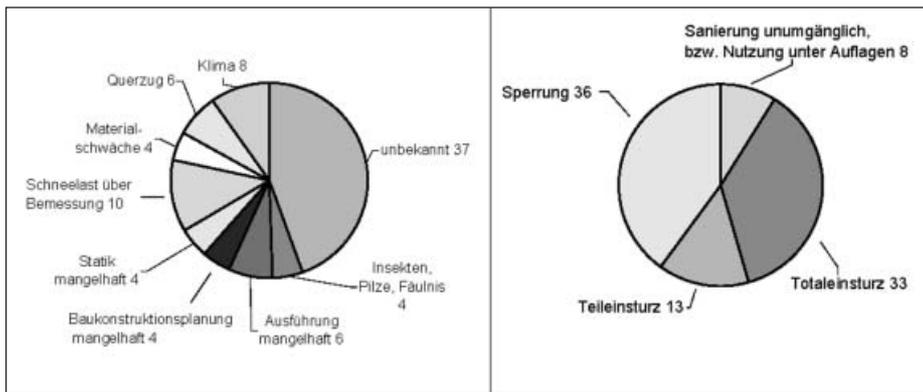
The current status of data evaluation shows that the main reasons for damage distributed over all kinds of building utilization are snow loads above the tolerance limit, room-climatic reasons and missing transverse pull calculations for the load bearing structures as well as faulty material, construction and planning (Fig. 1). Other reasons are missing or faulty reinforcing elements, later alteration measures and additional loads.

Snow loads above the design limit must be attributed to wrong assumptions of the planners or structural engineers. Room-climatic reasons resulting from long heating due to the long-lasting cold spell led to severe drying of the binders and increased crack formation. This usually does not affect agricultural buildings. The question of transverse pull, which mainly occurs in laminated board beams in addition to the bending stress in the beam and can lead to the ripping of the cross section was integrated into the standard in 1988 during the revision of DIN 1052 [1]. The necessity to consider this loading condition case during static calculations was confirmed only by long years of practical experience with long-span load-bearing structures and resulting binder heights. Defects of material particular in laminated board constructions are mainly caused by techniques of wood processing and –production which were common in the past for structural timber constructions [2]. In most cases of faulty workmanship, the plans and examined specifications were not correctly realized at the construction site. This also applies to missing or faulty reinforcing elements. Later alterations to structural elements are one reason for the failure of supporting structures. Even though such alterations may not be realized without prior calculation by a structural engineer and approval, unauthorized alterations were nevertheless carried out in technical constructions and in particular in older supporting structures, whose static system was often fundamentally changed, e.g. when cranes were installed.

Fig. 1: Distribution of the reasons for damage in buildings in the winter 2005/2006 (evaluation on behalf of the German Timber Promotion Fund, 2006)
